The Institution of Structural Engineers
47-58 Bastwick Street EC1

Isometric Detail of Stair

Hugh Broughton Architects

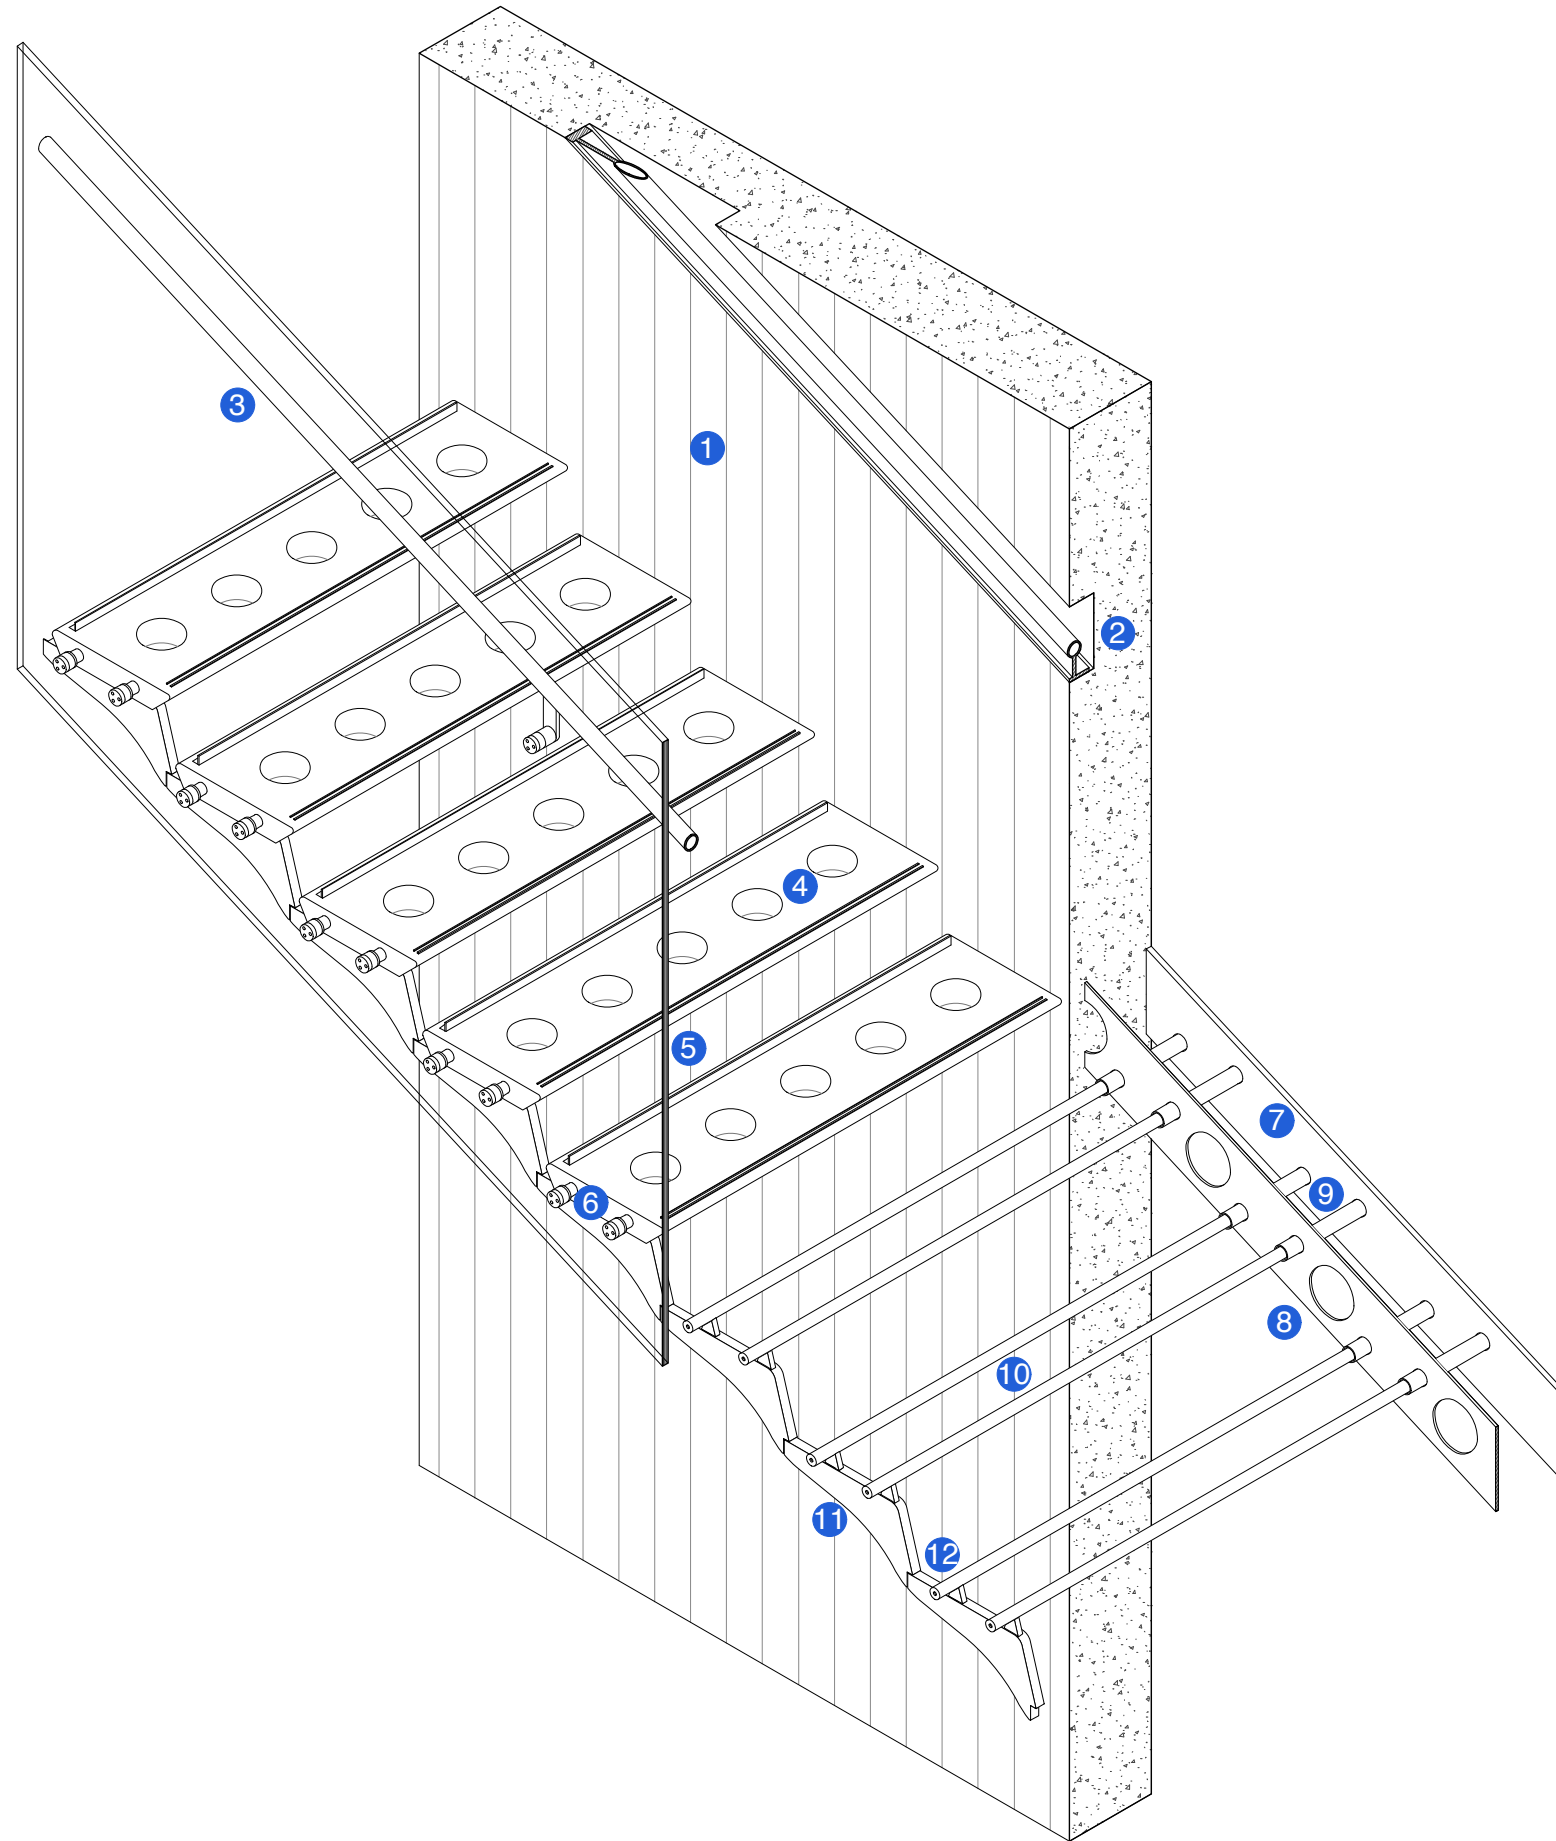
- ① In-situ board-marked concrete wall
- ② Continuous inset stainless steel handrail
- ③ Stainless steel handrail and fixing bracket
- ④ White precast concrete stair tread with inset frosted glass lenses, stainless steel kicker and nosing strips

- ⑤ Toughened laminated glass balustrade
- ⑥ Balustrade fixing points with stainless steel stainless steel cover plates with 3-point pig nose fixings
- ⑦ Primary steel stringer

- ⑧ Secondary steel stringer with regular holes to allow for free movement of concrete, cast within in-situ wall
- ⑨ Hollow stainless steel 'sleeves' located by stringers and cast into in-situ wall

- ⑩ Steel rods cast within stair treads pass through sleeves and are bolt-fixed to primary stringer
- ⑪ Machined steel 'cantilever' stringer plate with concealed stainless steel pin fixing, fully welded to steel rods

- ⑫ Ends of steel rods threaded in order to take balustrade fixings
