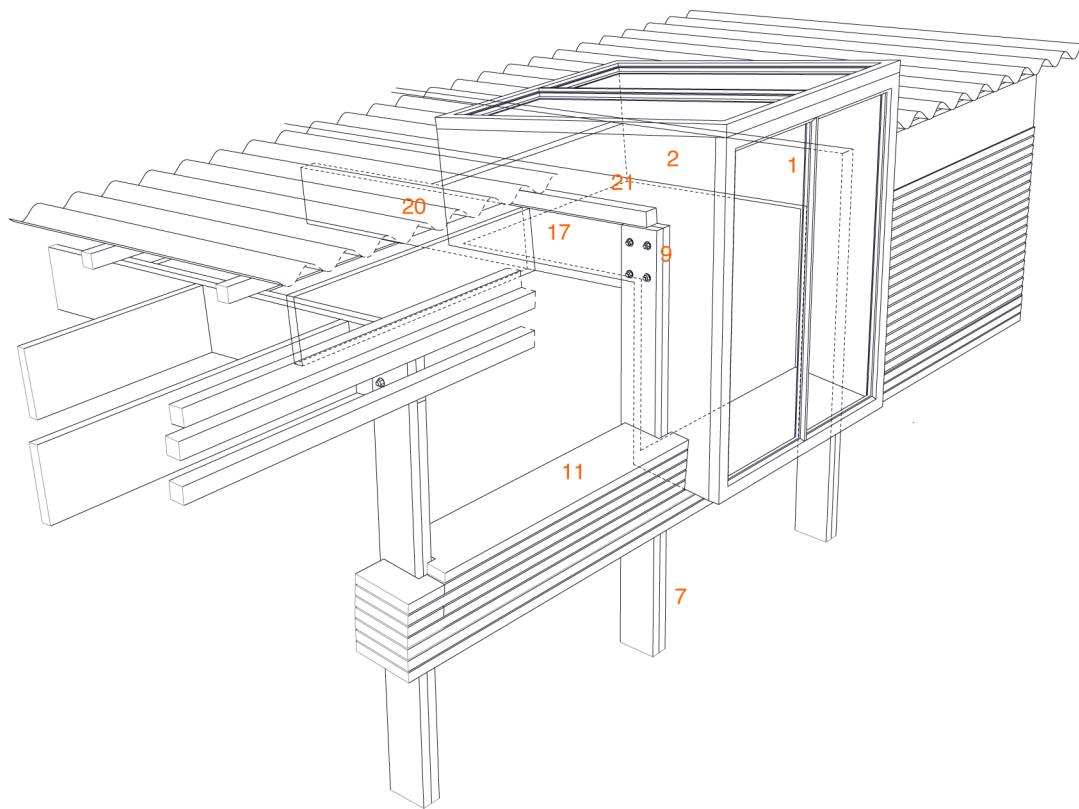
KEY

- 1 Reclaimed windows restored off site. Existing paint removed, new glazing refitted where necessary and restored frames painted white.
- 2 Window boxes built from two layers of 9mm plywood cut to size and assembled together off site. Windows constructed with a 5 degree fall to top and bottom.

- 7 2 no. 38 x 140mm cut scaffold board screwed together to form upright sections. One board cut shorter to allow lap of joist on top.
- 9 Uprights and roof joist to be fixed with 4 no. M8 coach bolts.

- 11 Cladding - Reclaimed scaffolding boards denailed, painted on either side with reclaimed paint and planed on edges.
- 17 Roof joist and noggins constructed using reclaimed scaffolding boards. Noggins staggered between joist to allow for simple assembly using screws.

- 20 Heavy duty vialux in the 8/3" C.Iron profile roofing material fixed at 762mm centres to timber support structure. Gutters and water harvesting system to collect rainwater for reuse.

- 21 2" x 2" Roofing battens
