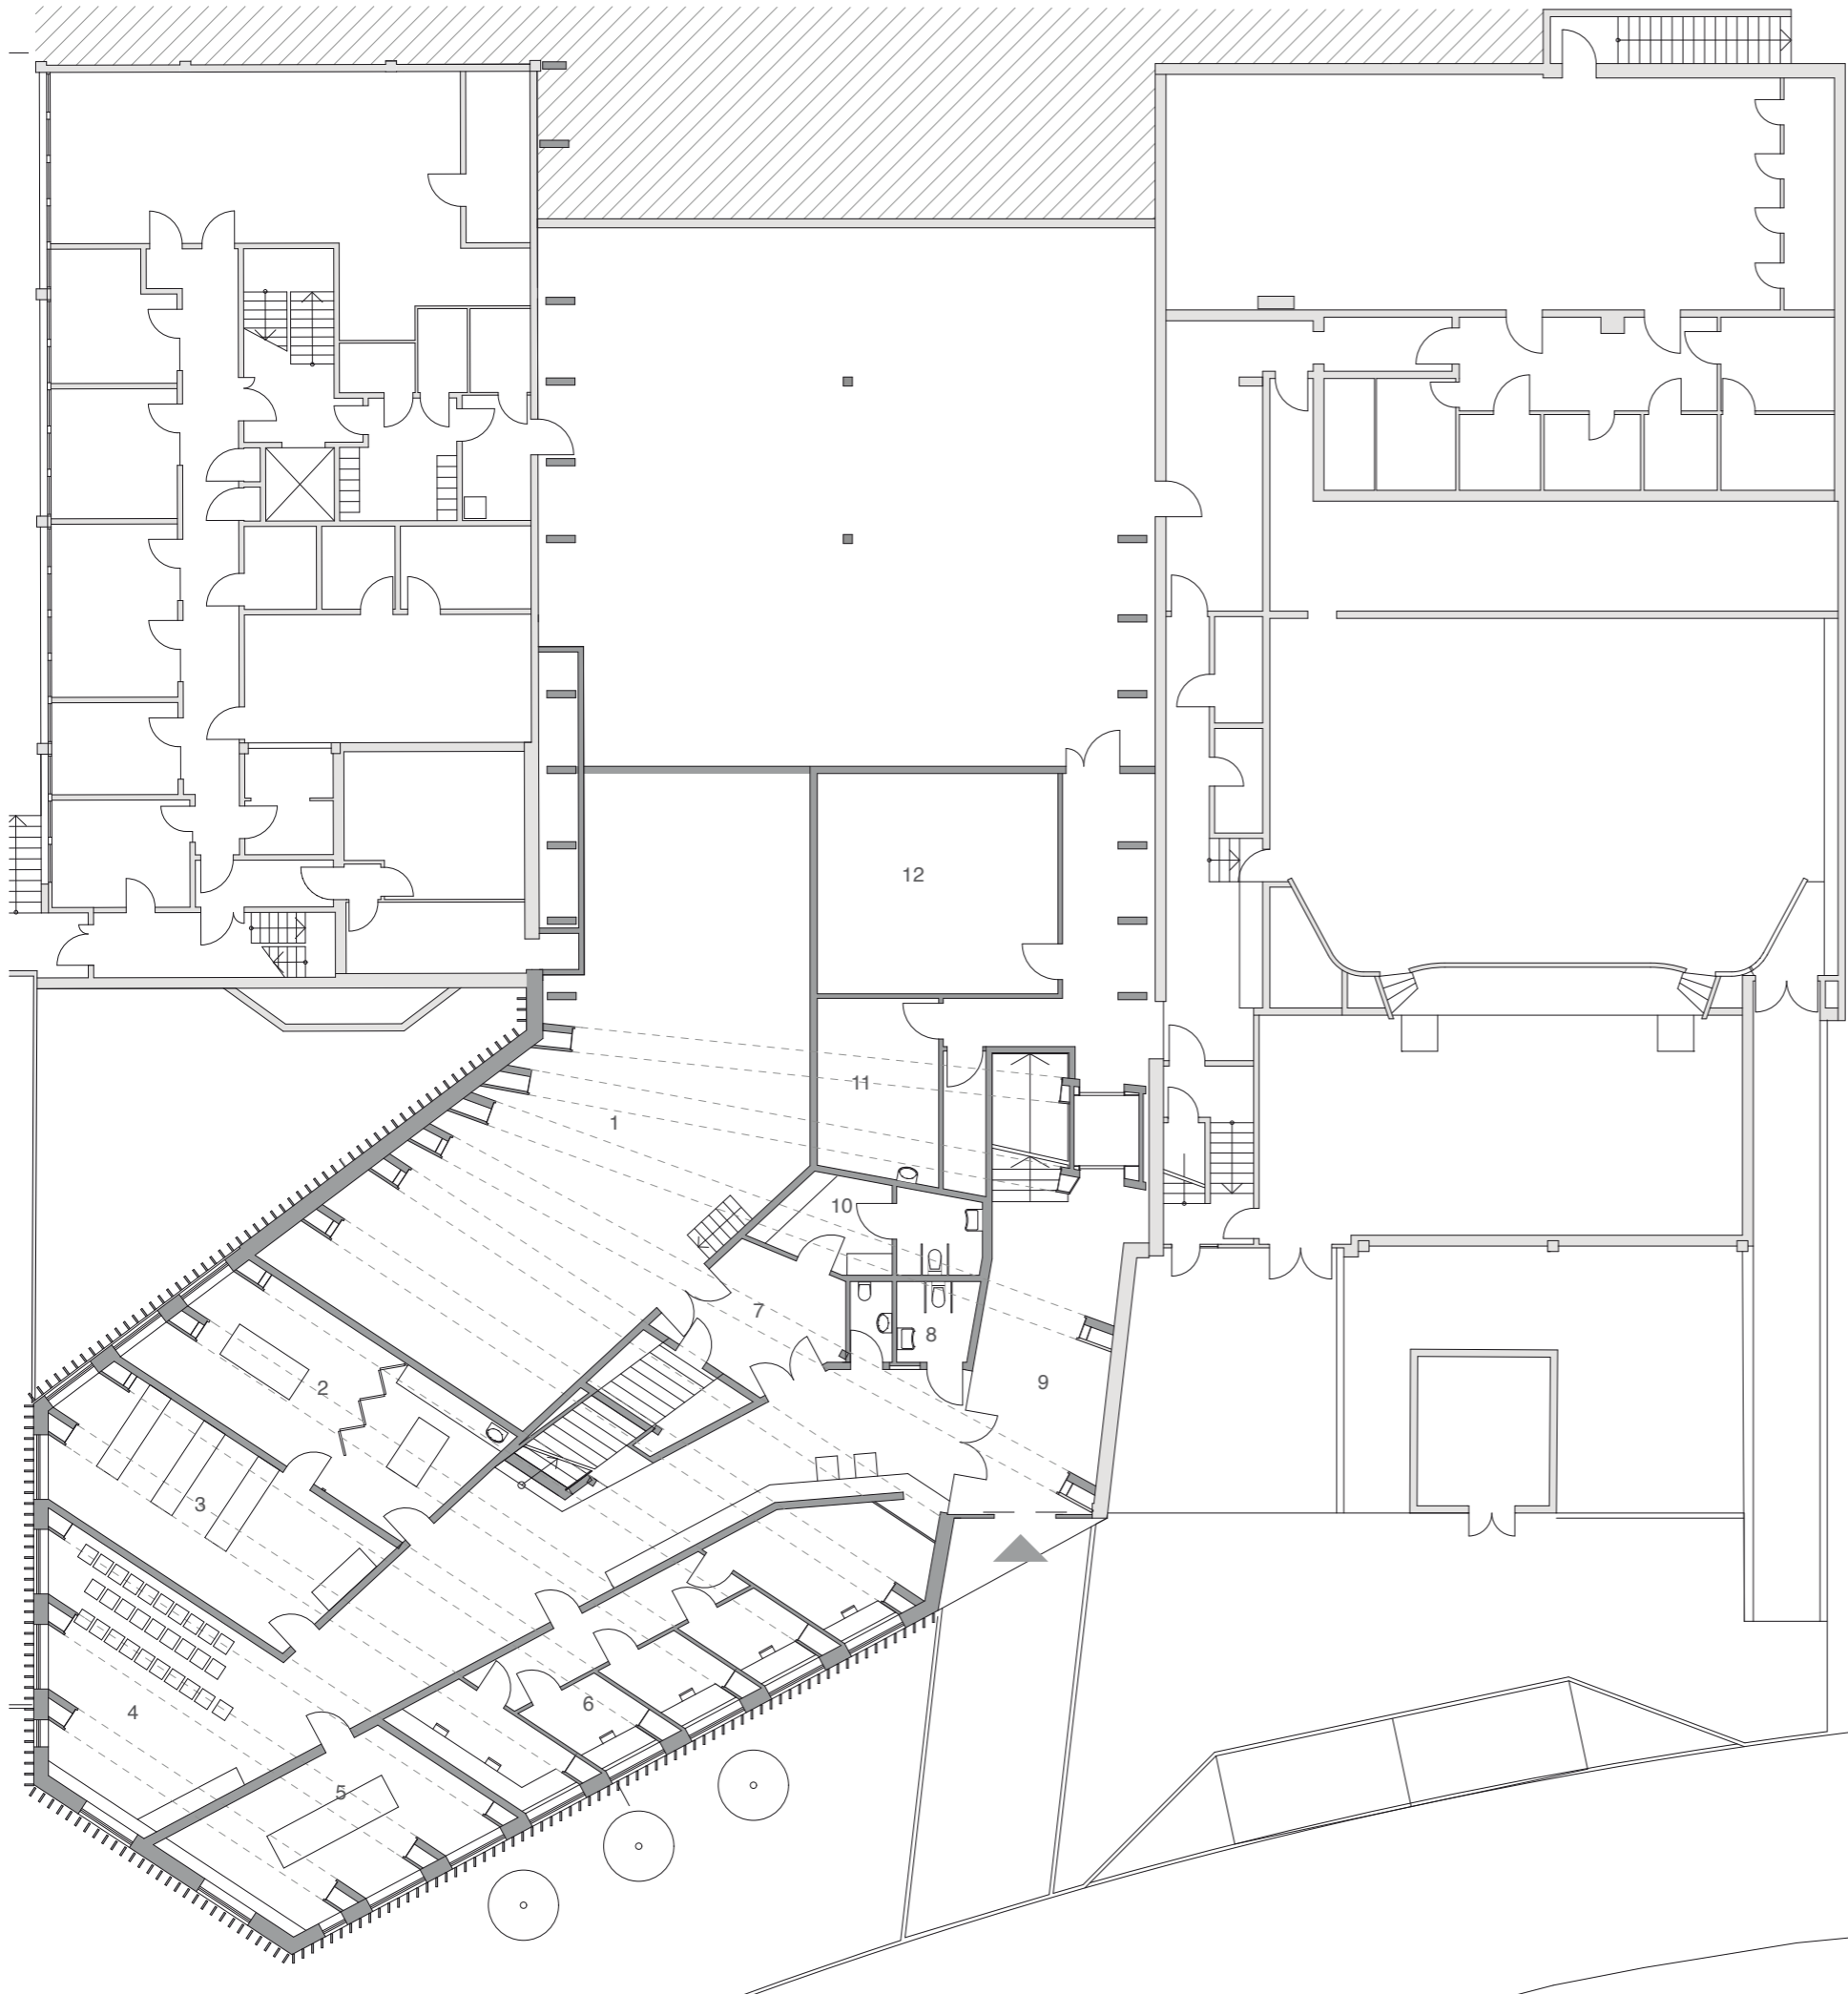
- 1. TECHNICAL ROOM
- 2. BREAK/MEETING/STUDY ROOM
- 3. LOCAL HISTORY COLLECTIONS
- 4. STORYTELLING ROOM
- 5. CLASSROOM
- 6. OFFICES
- 7. STORAGE
- 8. TOILETS
- 9. LOWER FOYER
- 10. WARDROBE
- 11. CLEANING ROOM
- 12. MAGAZINES

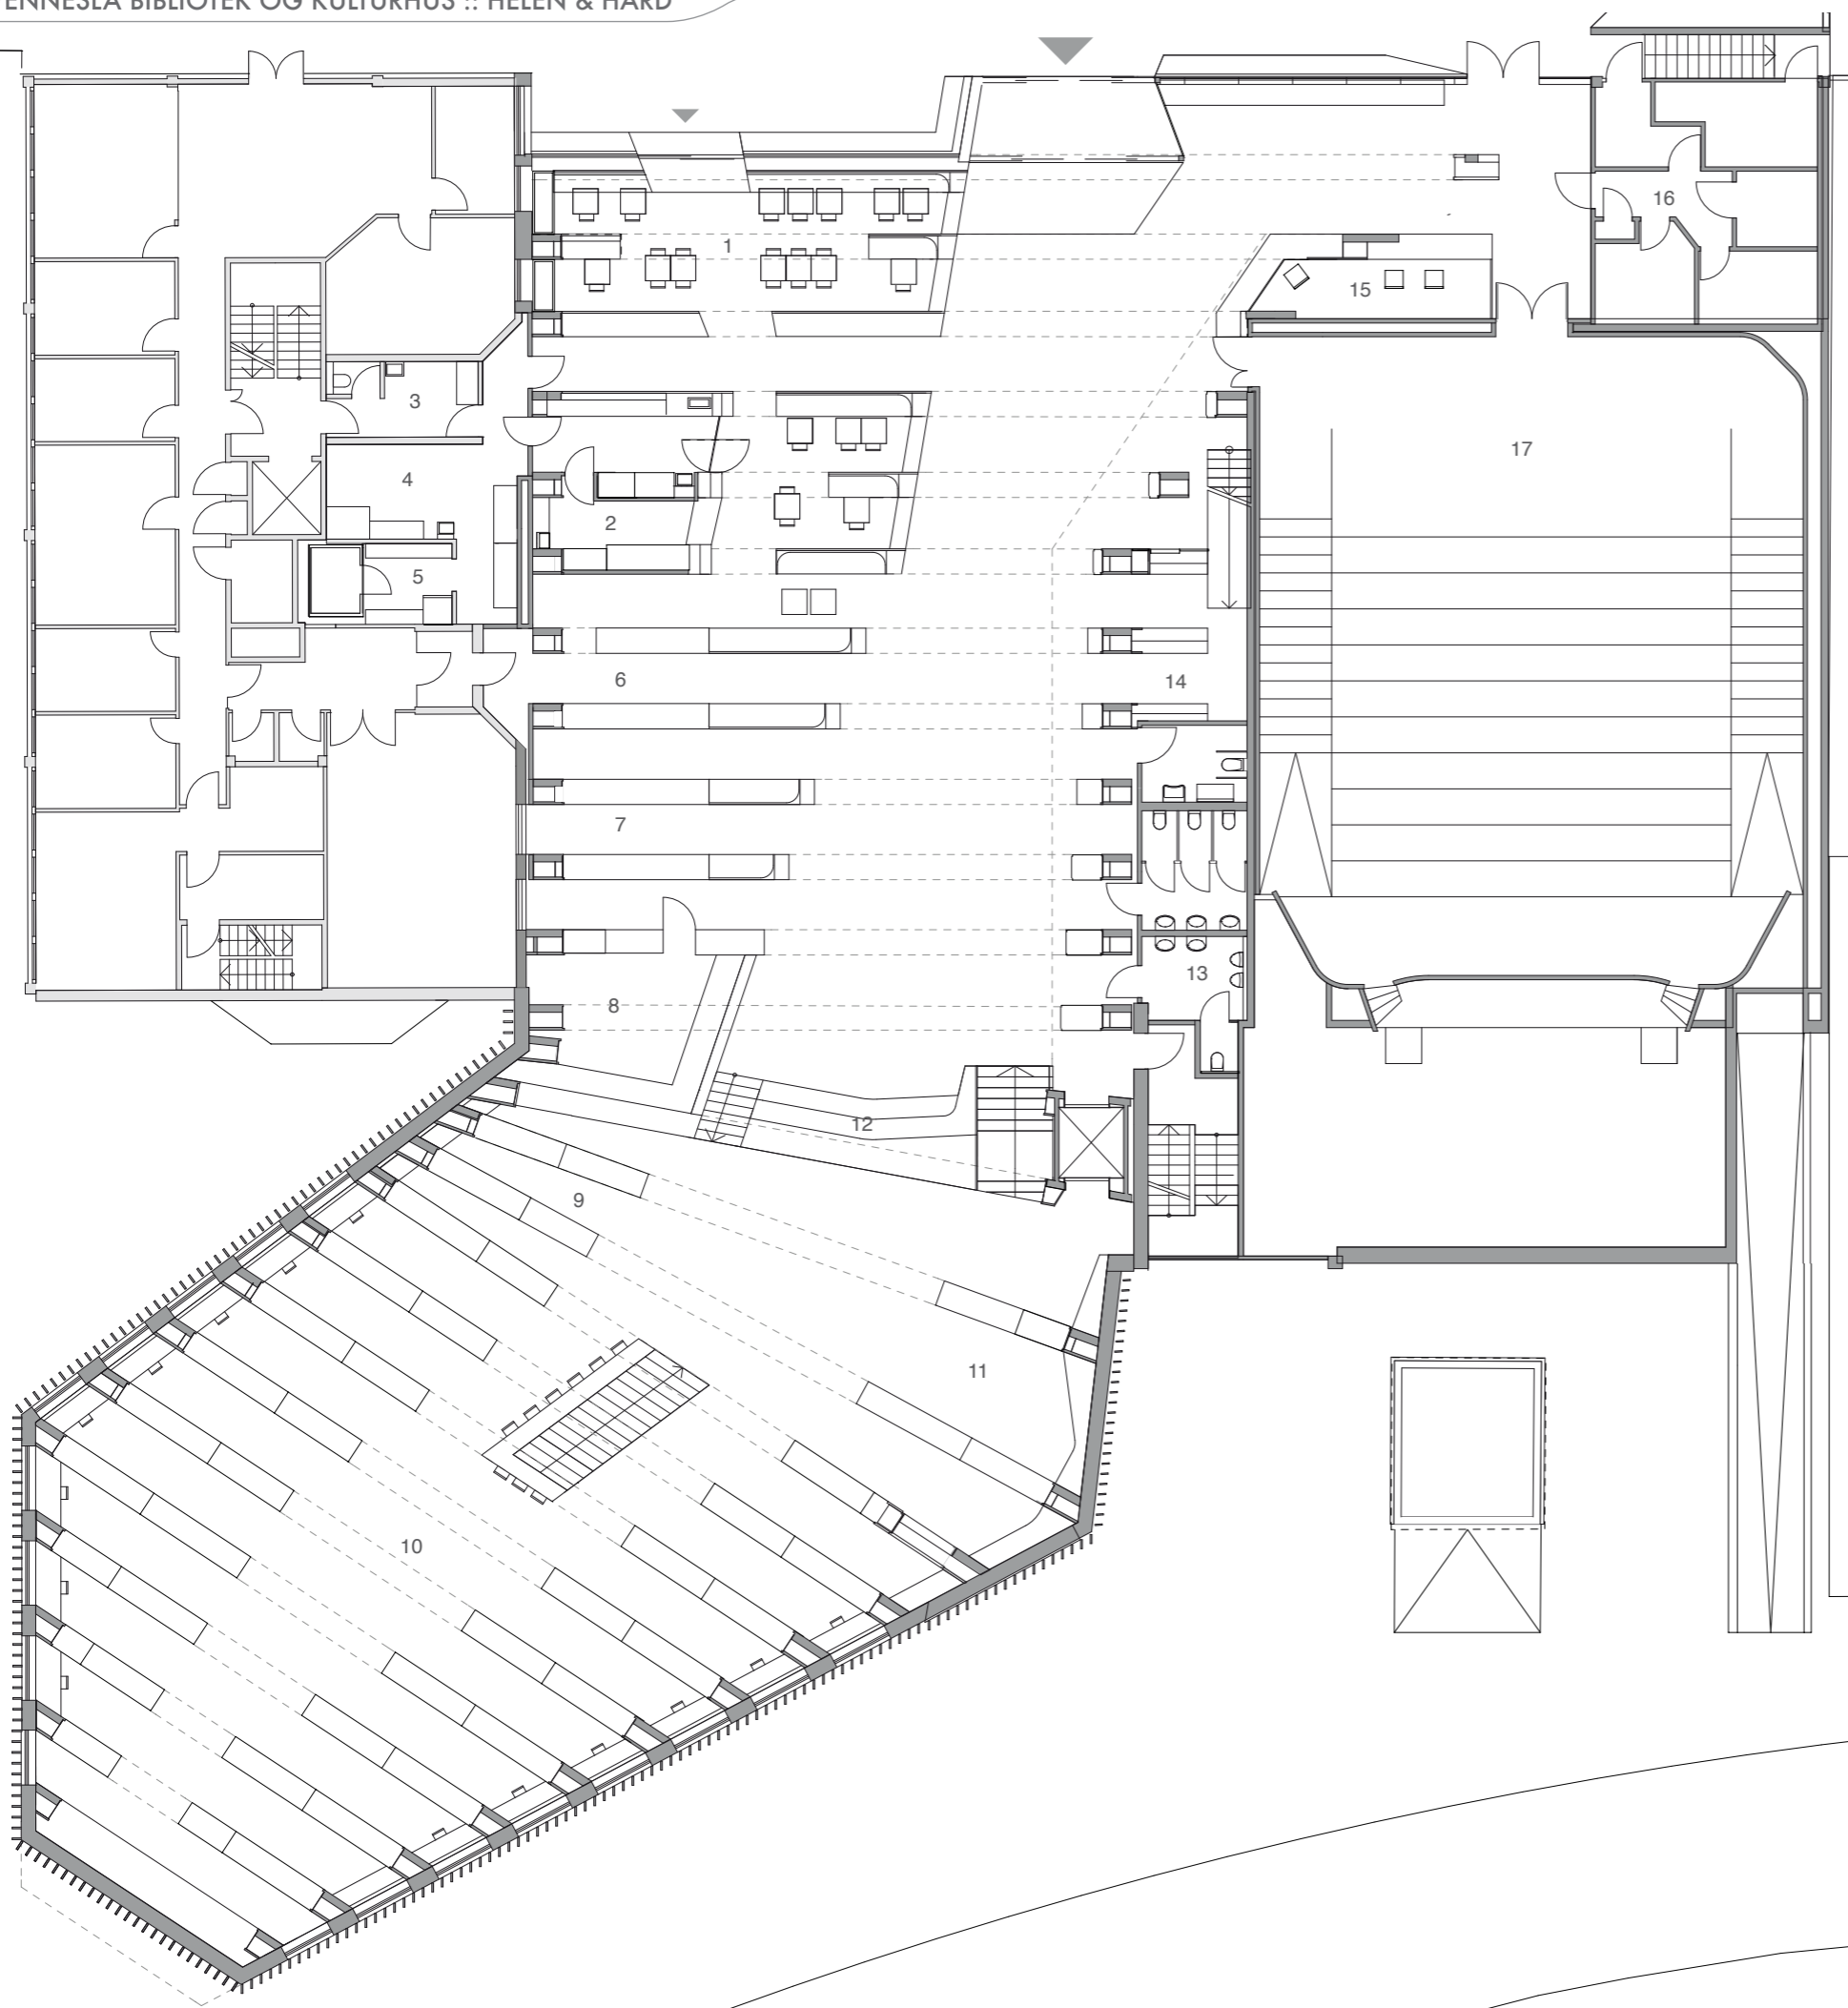
- 1. CAFE
- 2. WASHROOM
- 3. OFFICE
- 4. KITCHEN
- 5. STORAGE
- 6. PERIODICALS
- 7. FILMS/MUSIC
- 8. LIBRARY RECEPTION
- 9. CHILDREN'S COLLECTION
- 10. LIBRARY
- 11. YOUTH COLLECTION
- 12. AMPHITHEATER
- 13. TOILETS
- 14. WARDROBE
- 15. CINEMA RECEPTION
- 16. EXISTING TOILETS
- 17. EXISTING HALL

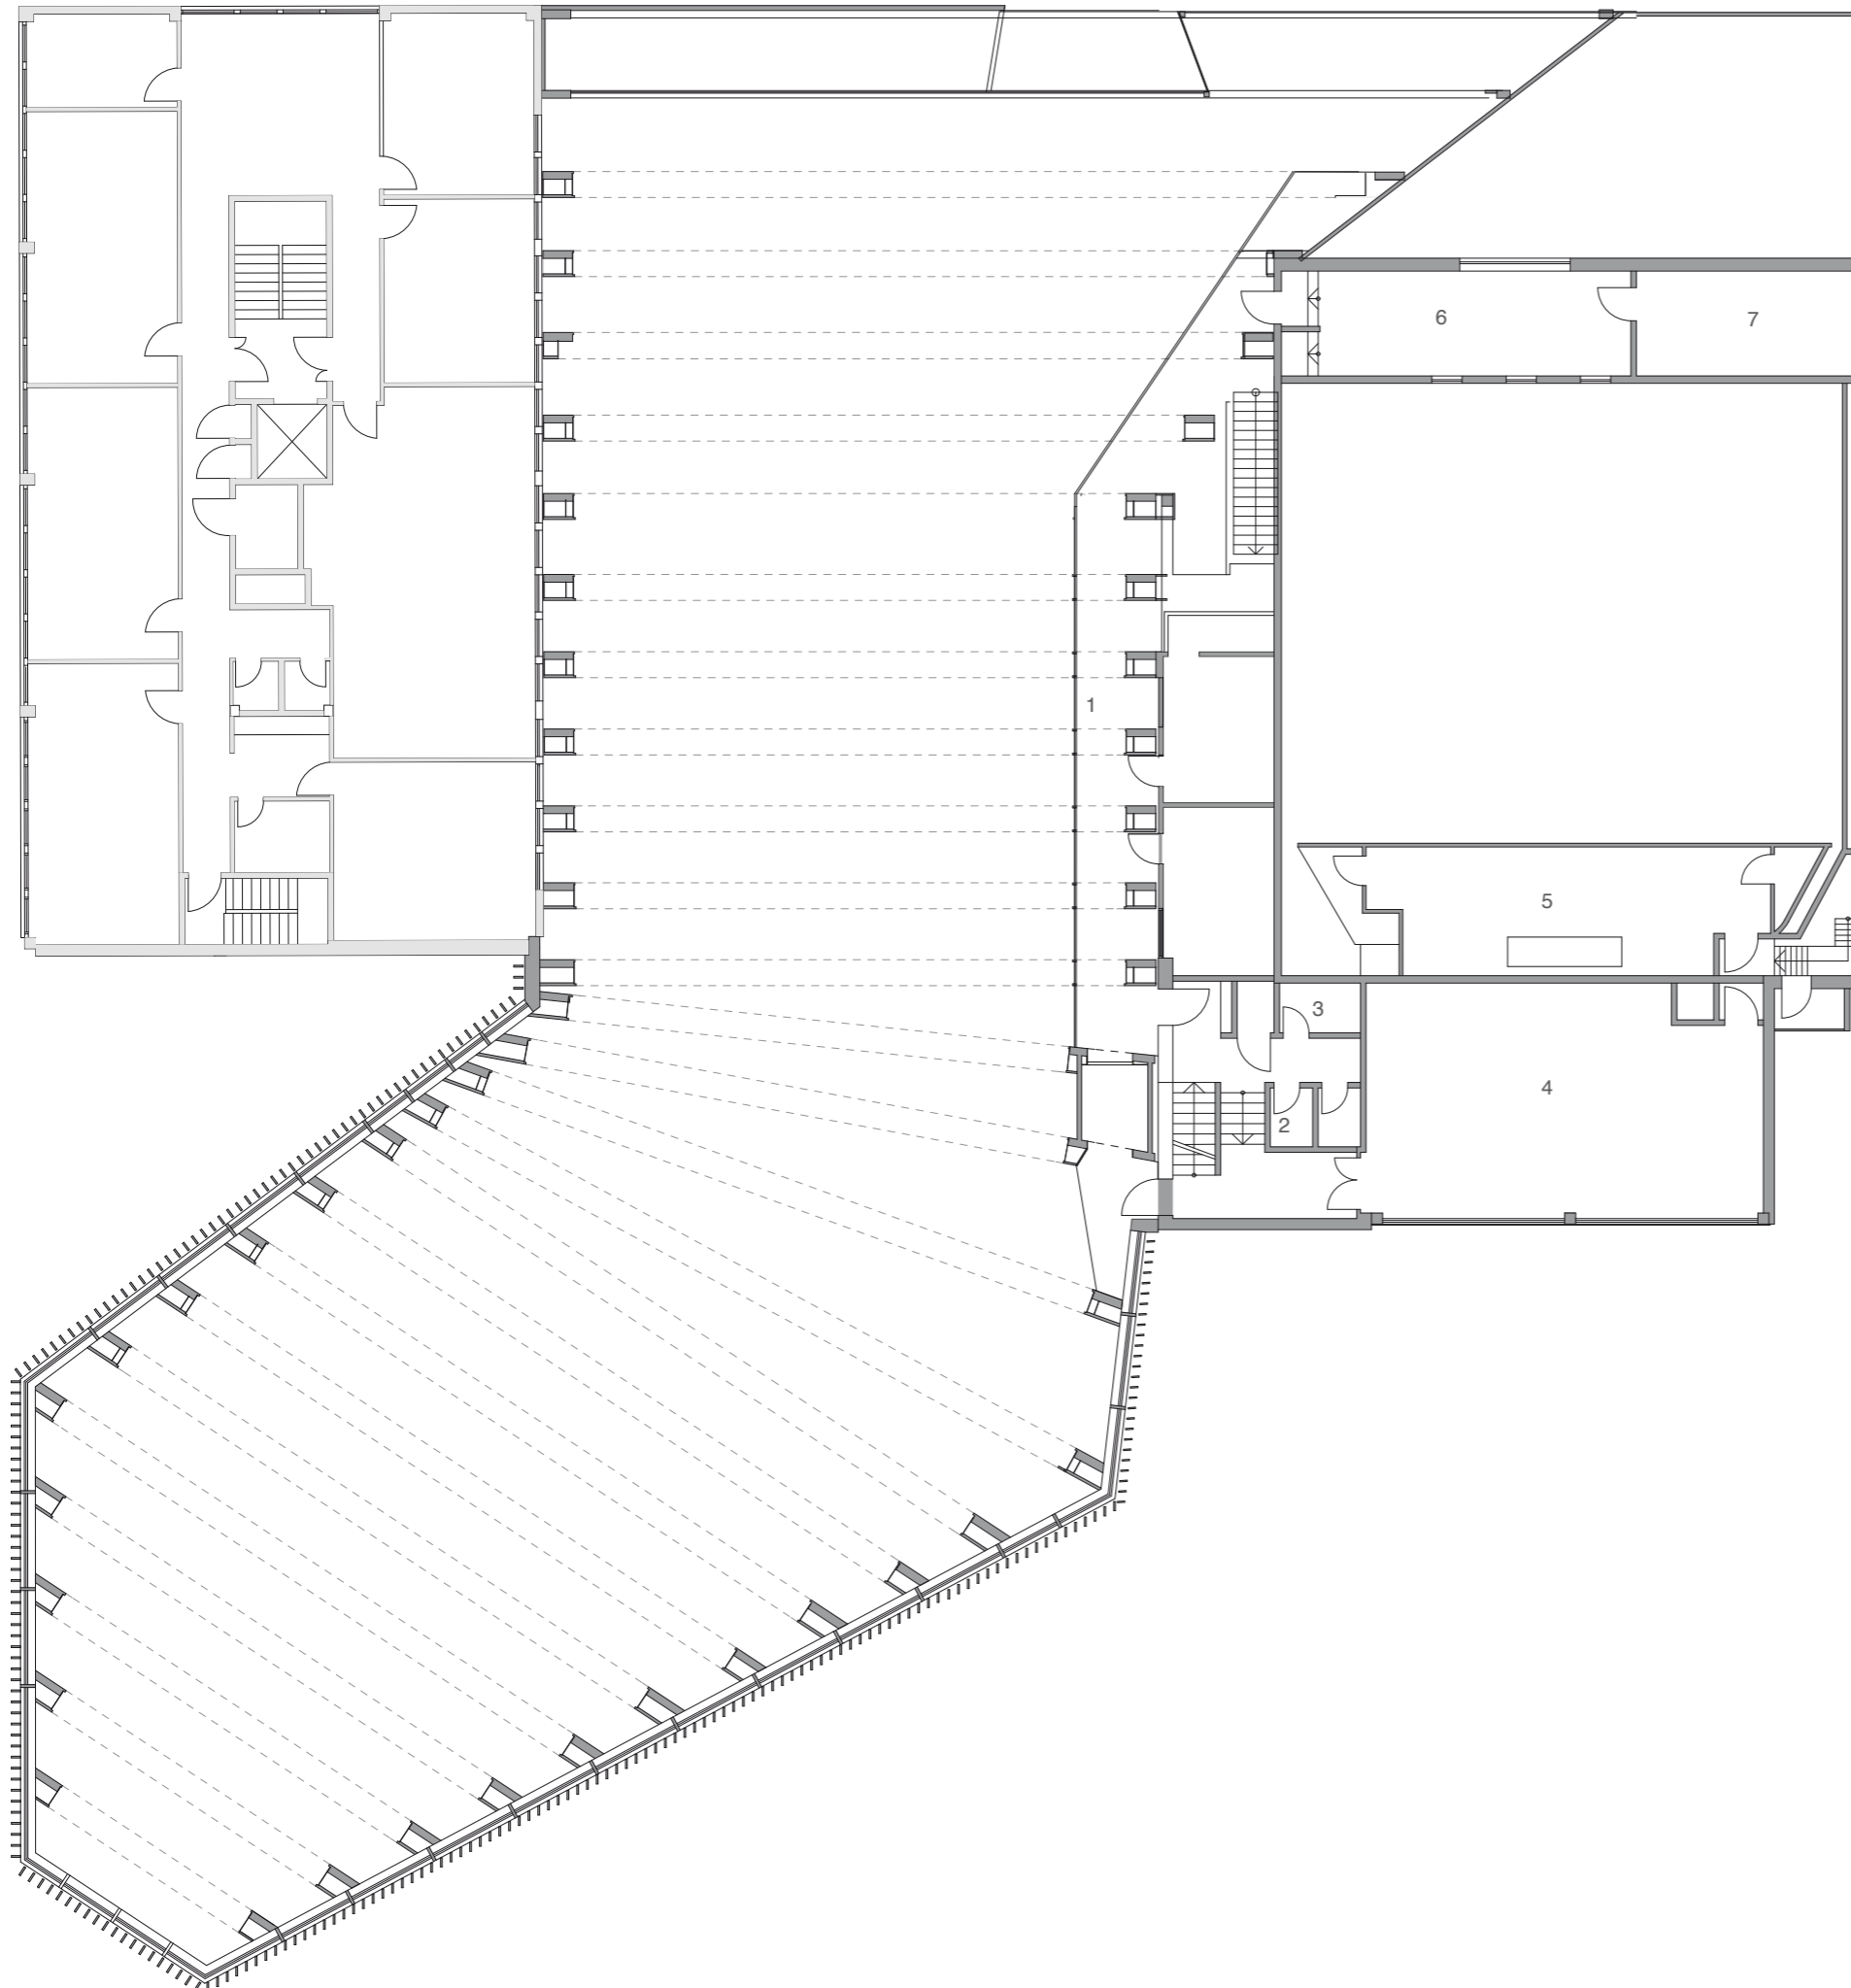
- 1. MEZZANINE
- 2. TOILETS
- 3. WASHROOM
- 4. EXISTING THEATER WARDROBE
- 5. EXISTING STORAGE
- 6. EXISTING MECHANICAL ROOM
- 7. EXISTING MECHANICAL ROOM

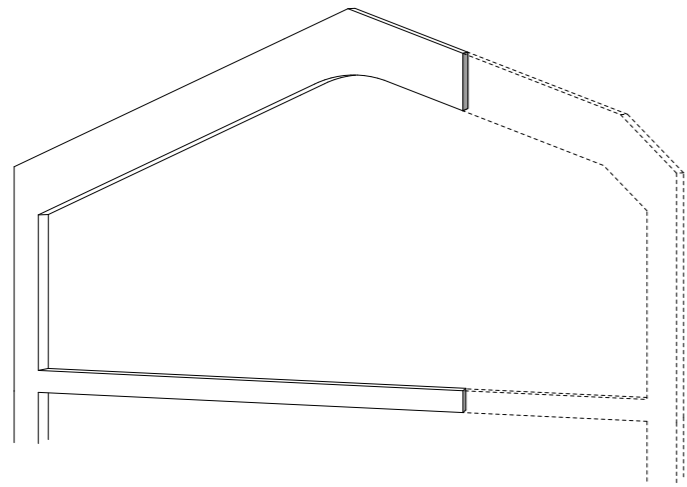
1. Construction

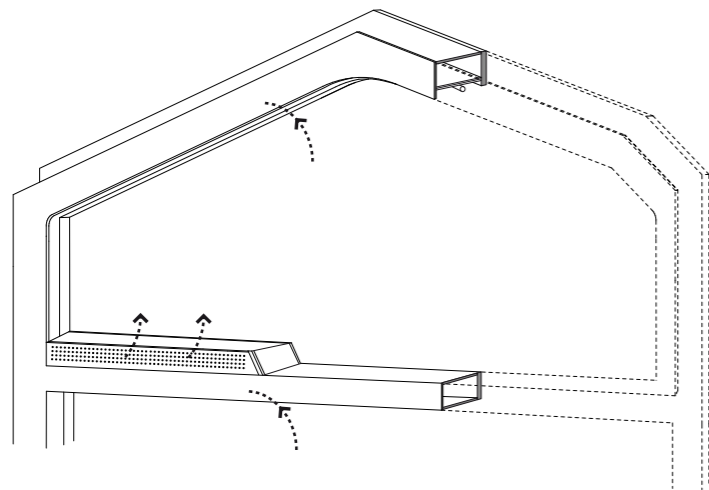
2. Infrastructure

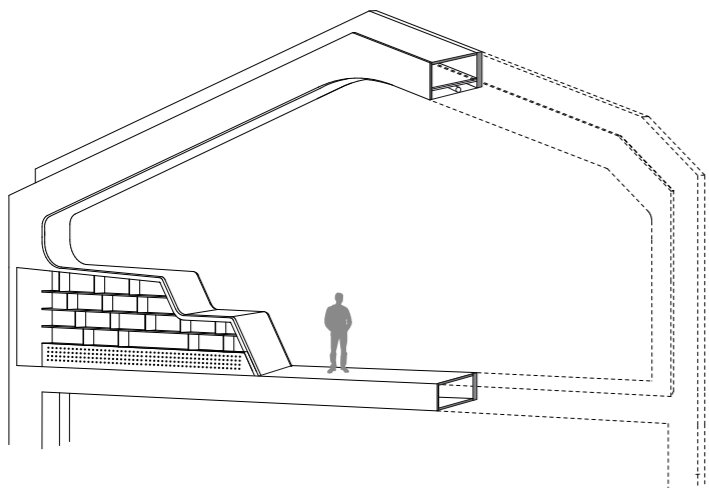
3. Add-on furniture

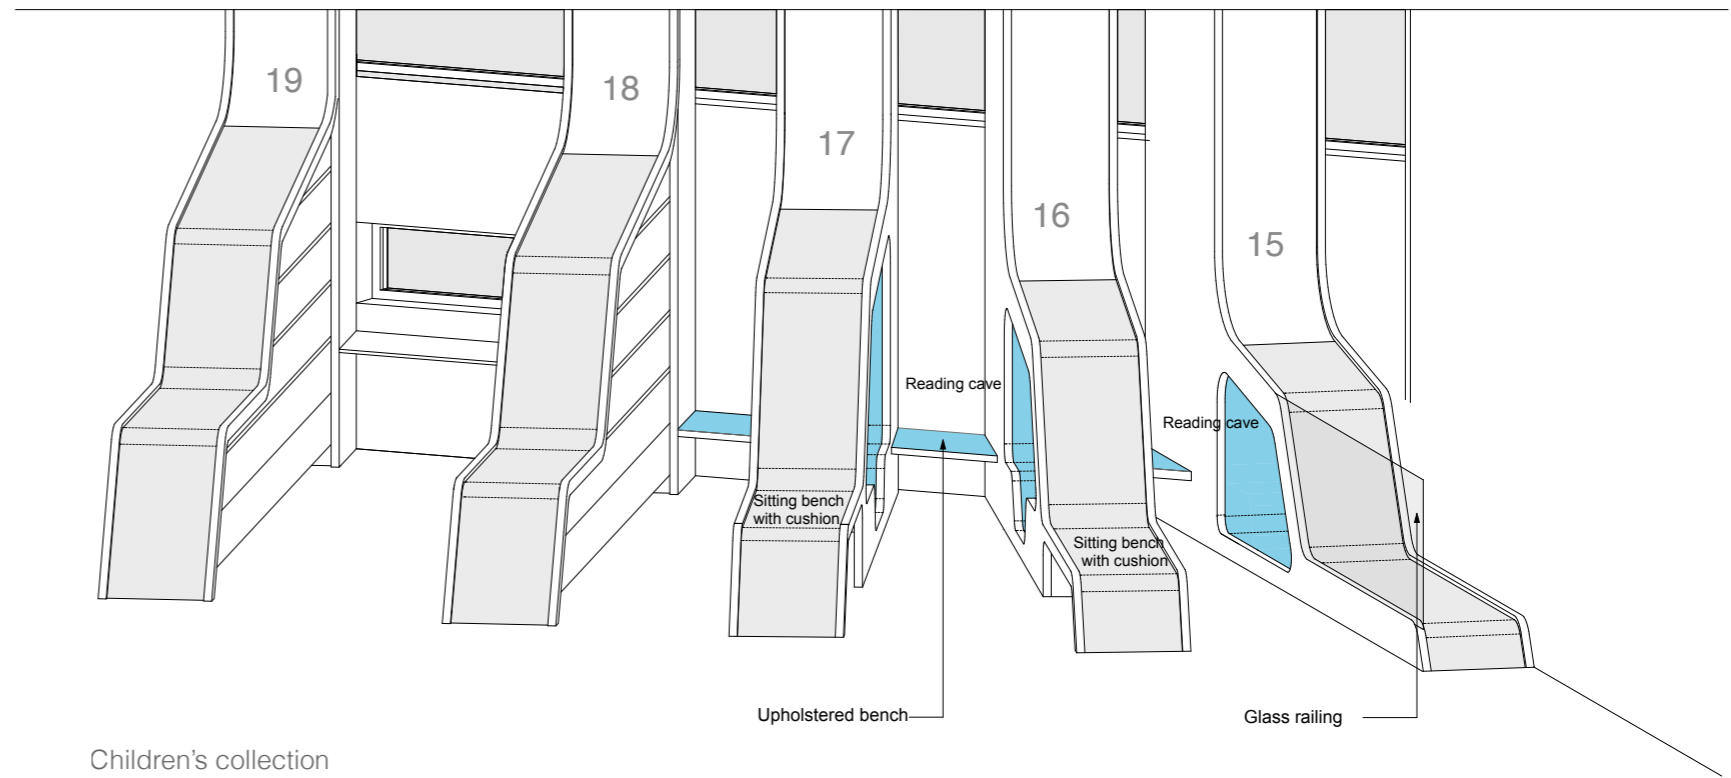
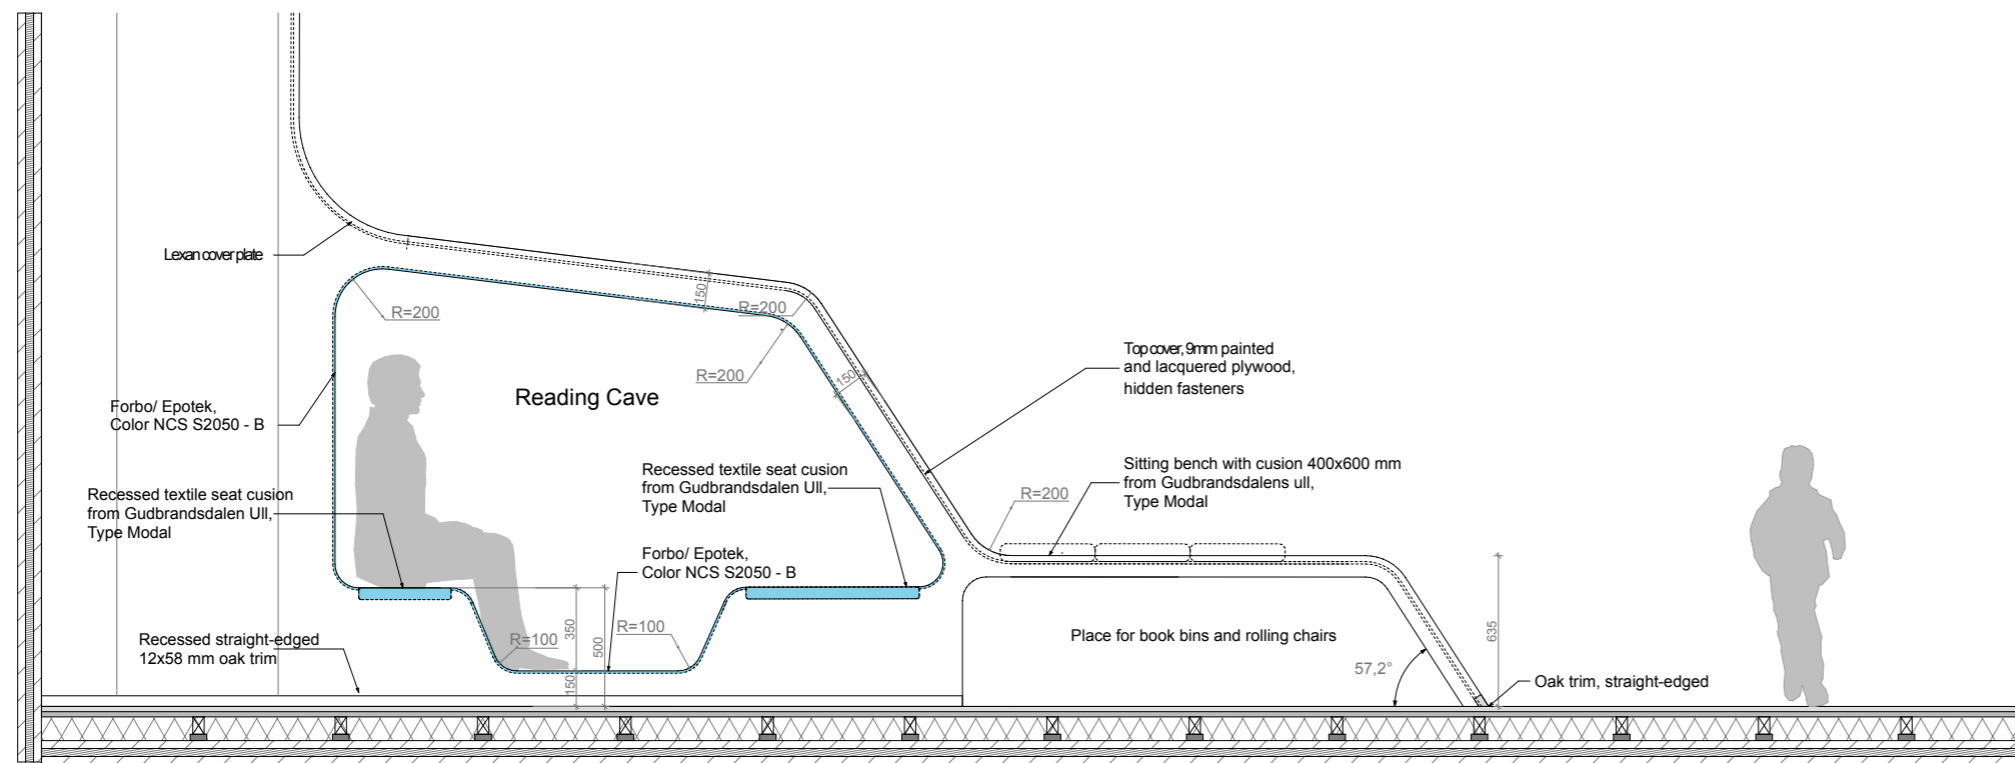
Detail section through reading cave

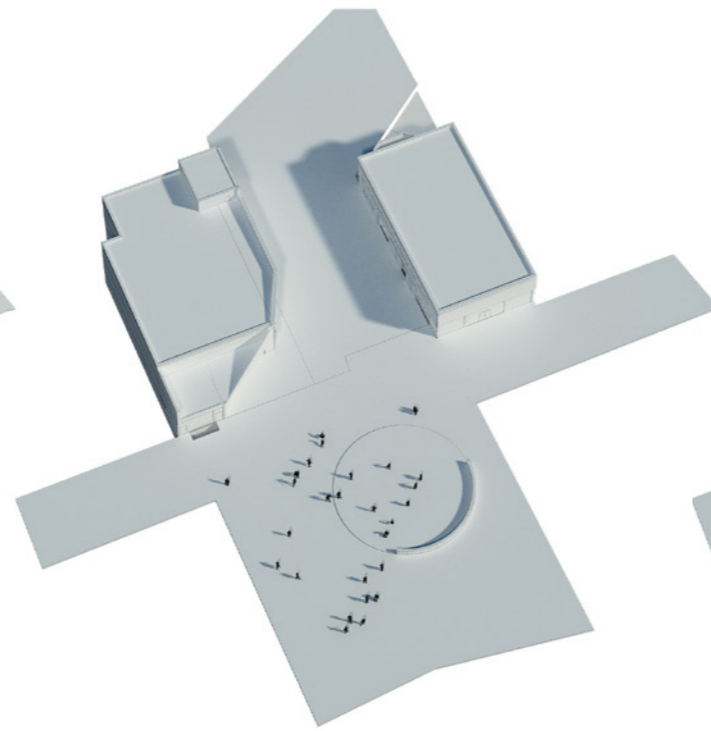
The existing cinema foyer is cut to maximise the interface between the new building and the town square

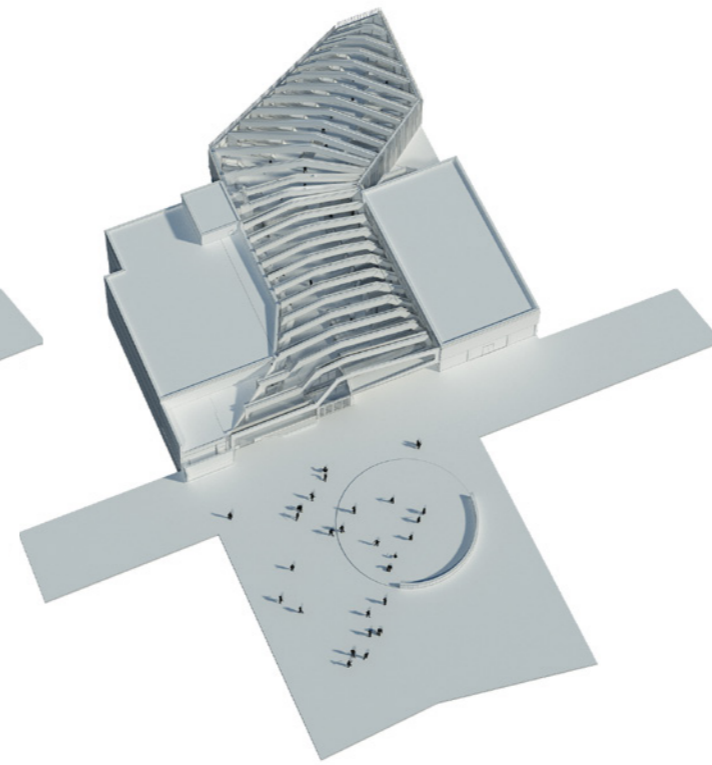
Rib structure in context
