SAUSSURE / North facade

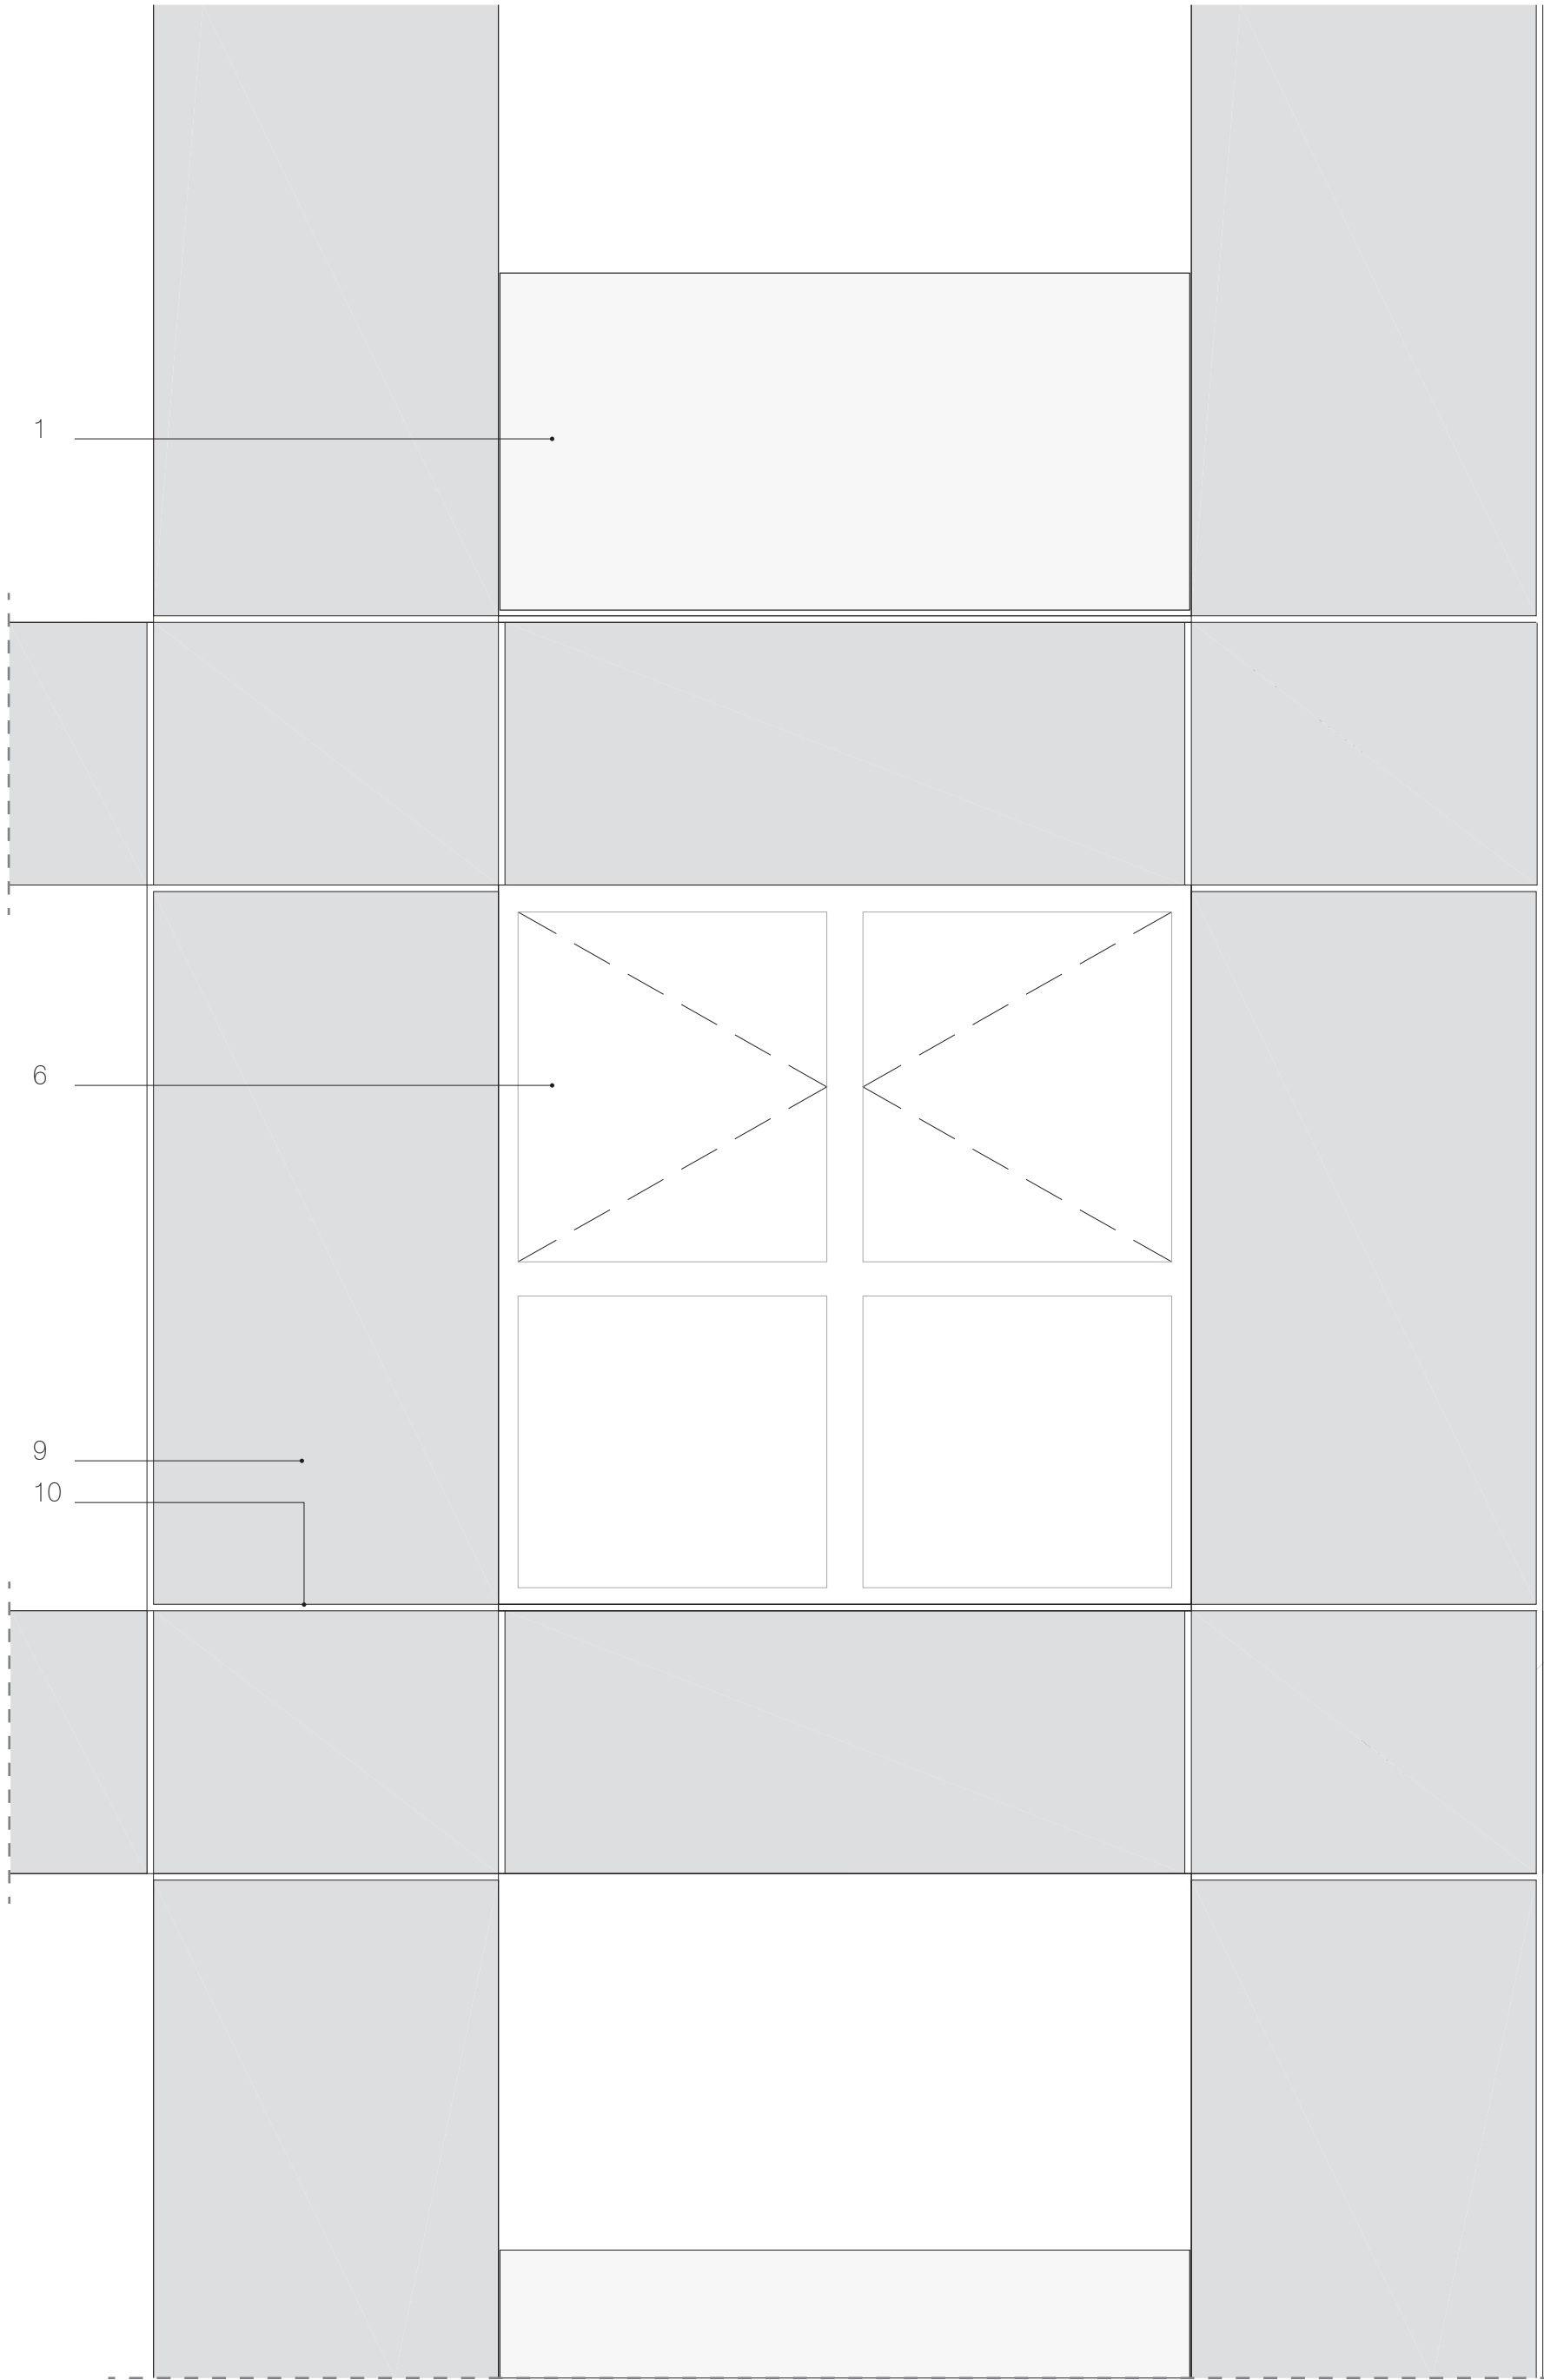
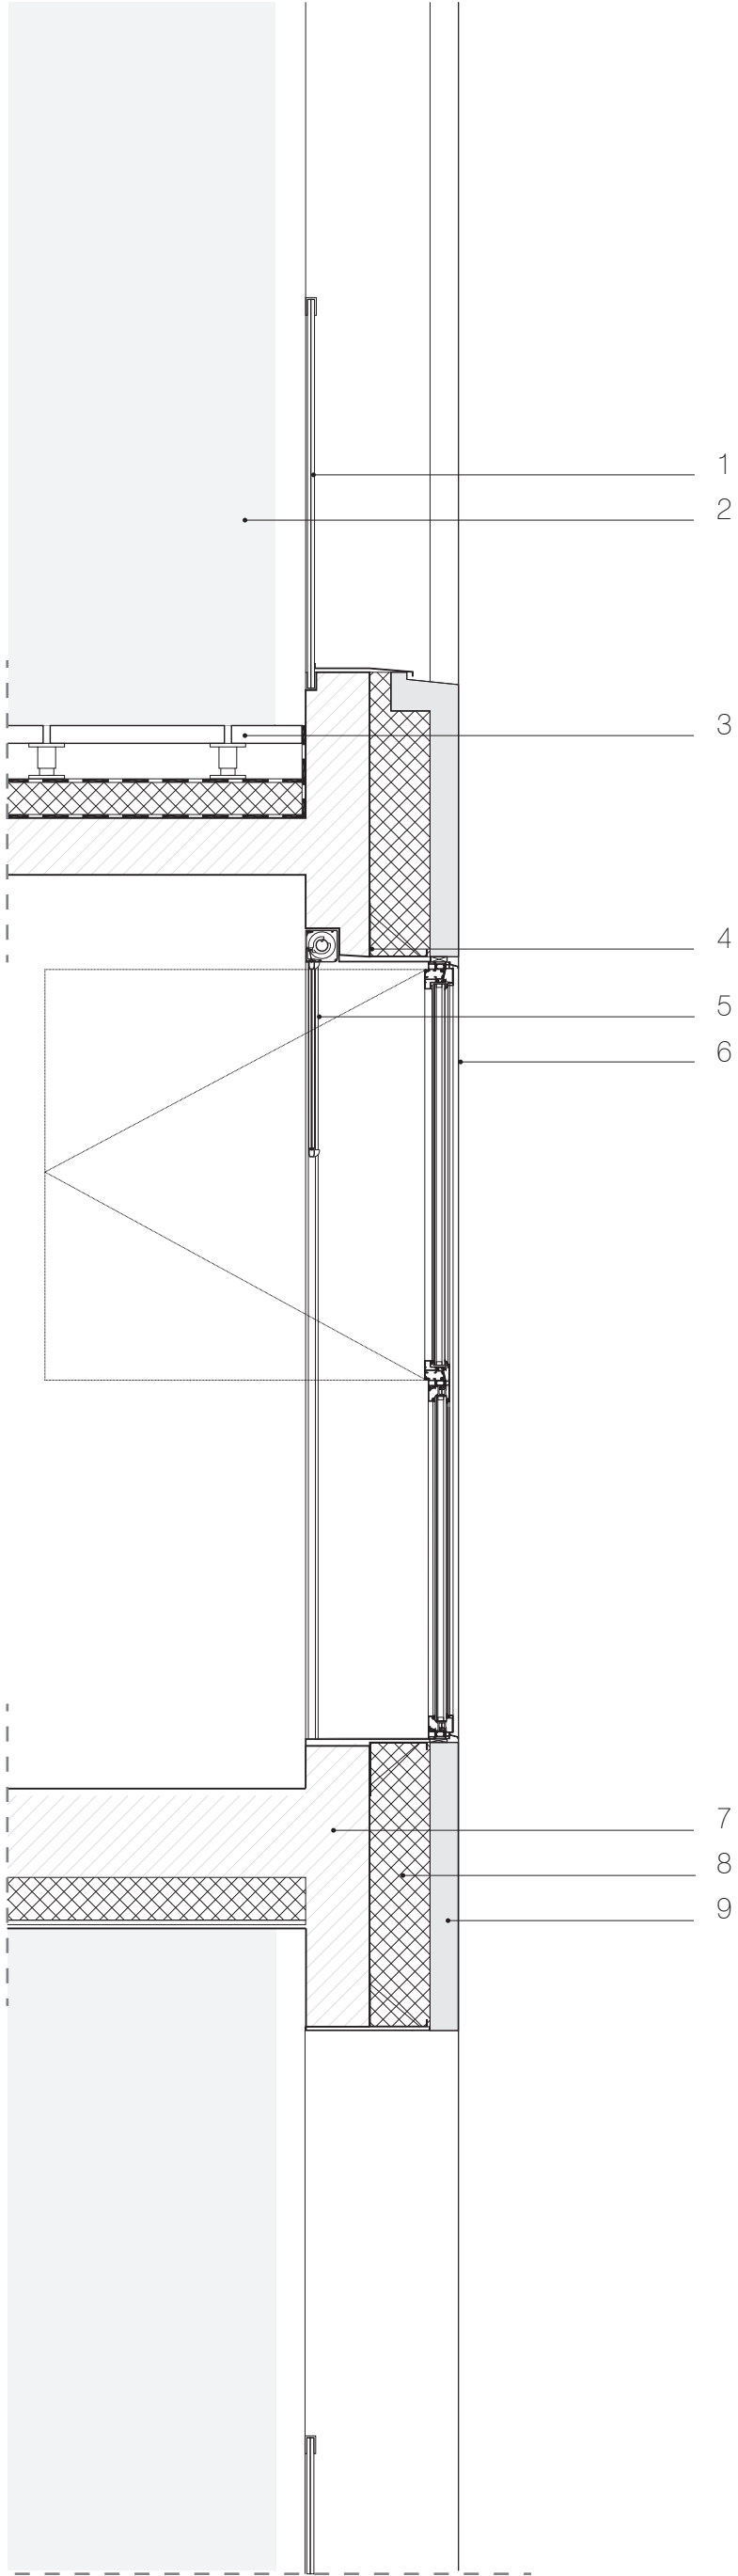
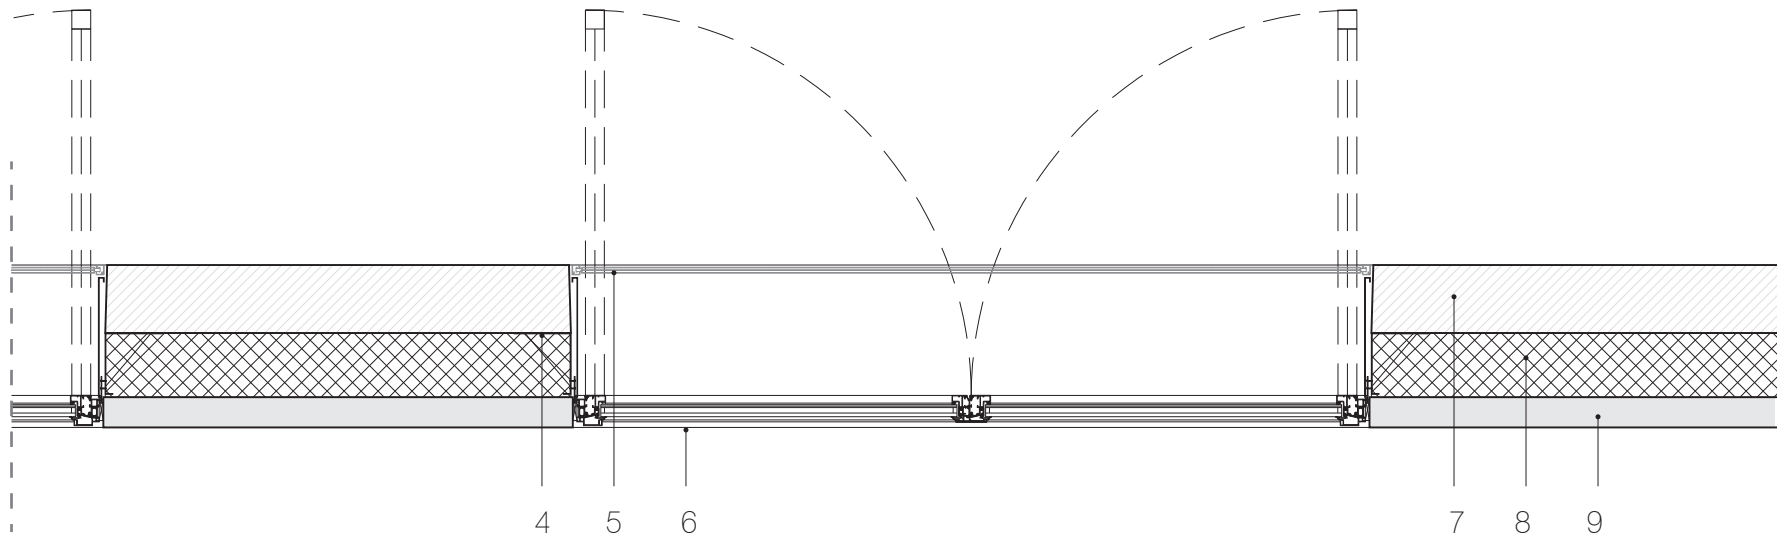
- 1 Glass railing
- 2 Loggia wall in lazured concrete
- 3 Timber slab on pads
- 4 Subframe in steel
- 5 Interior blind in fabric
- 6 Aluminum joinery, concealed vent  
2 casements opening inwards + fixed sill
- 7 Concrete bearing wall
- 8 Insulation
- 9 Concrete facing
- 10 Joint cavity
